Manhole Inspection Summary

Manhole # S07UU_017MH

Insp Date: **7/19/07 10:05 AM**

Location Address: **REAR 3622 FAIRVIEW AVE**

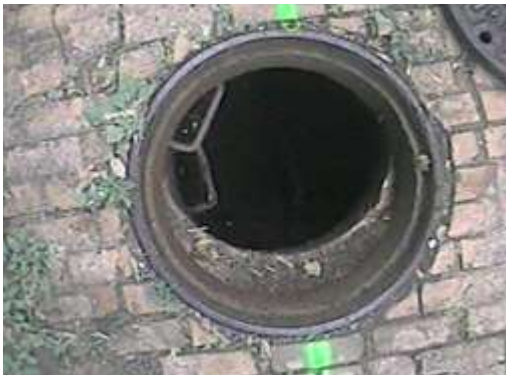
Defect 1

Frame Offset: **4** (in.) Condition: ☒ Sound ☐ Cracked ☐ Leaks

FRAME OFFSET

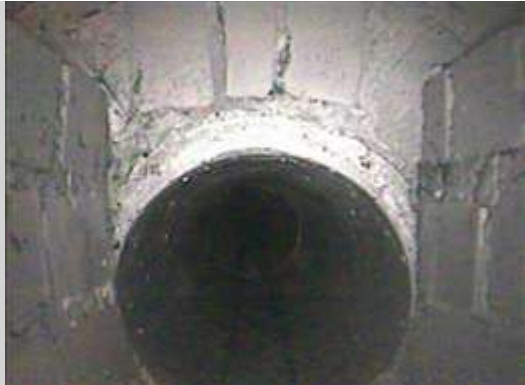
12 O'Clock Outflow

8 in. Circular Gravity Sewer
Pipe Out @ 12 O'Clock

Pipe Height: (in.) Direct
Pipe Material: **Clay** ☐ Pipe Lined
Invert Depth: **8.82** (ft.) Flow Characteristics: **Slow**
Deposits: ☒ None ☐ Mud ☐ Sludge ☐ Debris ☐ Grease
Silt Depth: (in.) Deposits Extent:
Infiltration: **None** Pipe Seal Cond: **Sound**

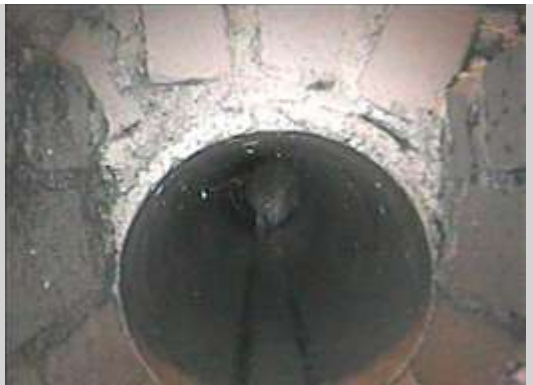
6 O'Clock Inflow

8 in. Circular Gravity Sewer
Pipe In @ 6 O'Clock

Pipe Height: (in.) Direct
Pipe Material: **Clay** ☐ Pipe Lined
Invert Depth: **8.84** (ft.) Flow Characteristics: **Slow**
Deposits: ☒ None ☐ Mud ☐ Sludge ☐ Debris ☐ Grease
Silt Depth: (in.) Deposits Extent:
Infiltration: **None** Pipe Seal Cond: **Sound**
